Protect Your Home, Family, Pets & The Environment

Carefully clean and inspect the filter bowl prior to replacing the filter at the start of each heating season.

We recommend replacement of any pre-2009 galvanized filter bowls with newer epoxy coated version introduced in 2009

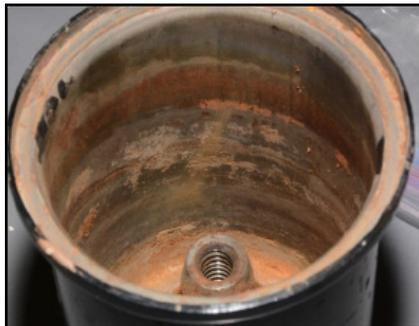
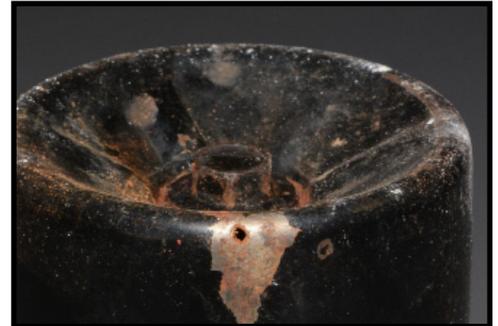
If You See This:

- Rust or Corrosion
- Hole In Bottom of Can
- Rust on outside of can

If any of the defects listed above, or any other defect is found:

Install a New Epoxy-Coated Oil Filter or Filter Bowl Kit Today!

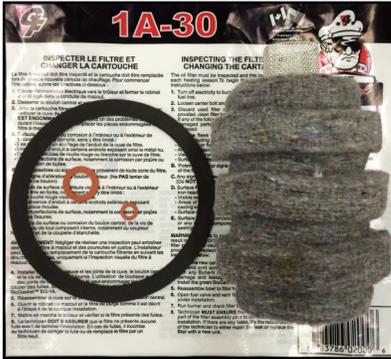
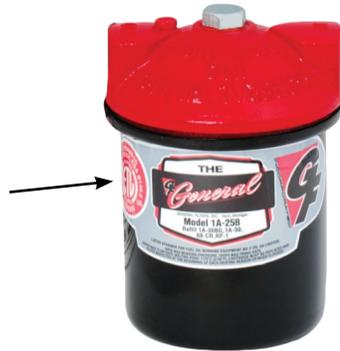
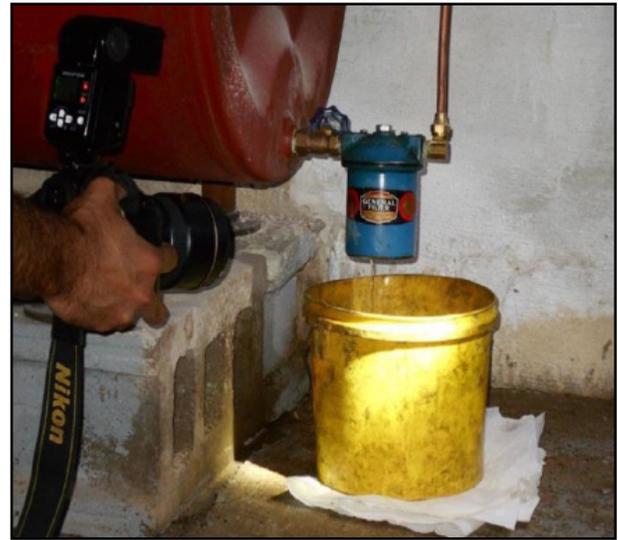
This Could Have Been Avoided.

This oil leak resulted in a house being bulldozed, and the home owner filing a \$1,000,000 claim; all because the technician put in a competitor's replacement filter that pinched the gasket and created a leak.

Use Only General Filters Approved Products
